# Cooperative Lakes Monitoring Program

## 2015 Data Report for Maceday Lake, Oakland County

Site ID: 630415

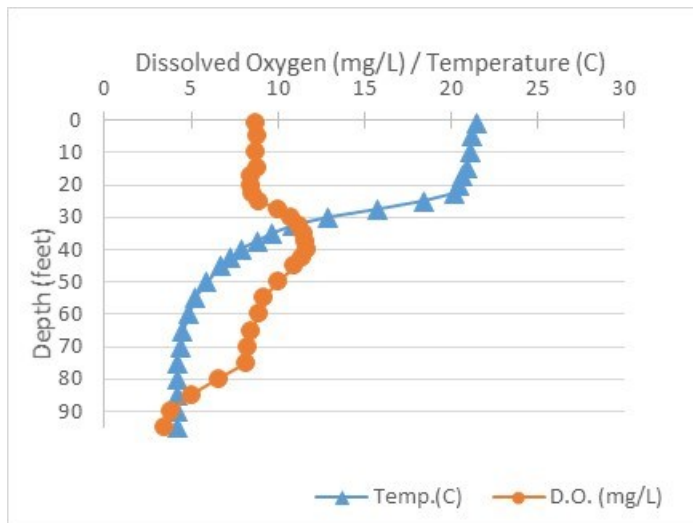
### Dissolved Oxygen and Water Temperature Profile: Sept 2015

If you enrolled in Dissolved Oxygen/Temperature, the summary page will have a graph of one of the profiles taken during the late summer (typically August or September). A late summer graph is used because dissolved oxygen is often depleted in the late summer, and identifying this condition and the depth at which it occurs is typically the most important use of dissolved oxygen measurements.

With an average TSI score of 33 based on Secchi transparency, chlorophyll-a, and summer total phosphorus, this lake is rated as an oligotrophic lake. The low level of nutrients in the lake results in dissolved oxygen being available throughout the water column for the entire summer. There is too little data to assess long term trends. CLMP recommends eight years of consistent monitoring in order to develop a strong data baseline. Welcome to the CLMP! The longer you stay in the program, the more interesting this report will become.

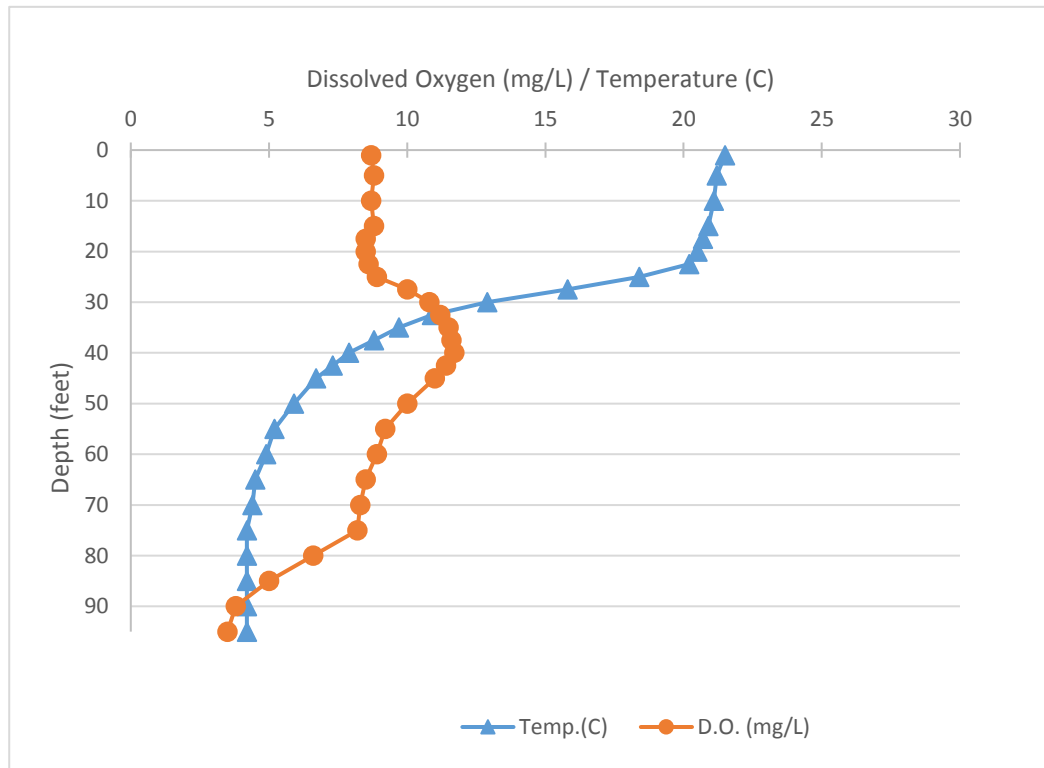
9/16/2015

### Dissolved Oxygen and Temperature Profile

Depth (ft)	Temp.(C)	D.O. (mg/L)
1	21.5	8.7
5	21.2	8.8
10	21.1	8.7
15	20.9	8.8
17.5	20.7	8.5
20	20.5	8.5
22.5	20.2	8.6
25	18.4	8.9
27.5	15.8	10
30	12.9	10.8
32.5	10.9	11.2
35	9.7	11.5
37.5	8.8	11.6
40	7.9	11.7
42.5	7.3	11.4
45	6.7	11
50	5.9	10
55	5.2	9.2
60	4.9	8.9
65	4.5	8.5
70	4.4	8.3
75	4.2	8.2
80	4.2	6.6
85	4.2	5
90	4.2	3.8
95	4.2	3.5
